***CABLE FAILURES AND
PROTECTIVE RELAY OPERATION
ASSOCIATED WITH
NASA GLENN'S
10x10 SUPERSONIC WIND TUNNEL***

Cass Kuhl
Hadron, Inc
NASA Glenn Research Center
Cleveland, Ohio

Supersonic Tunnel Association International Meeting
University of Notre Dame
April 2002

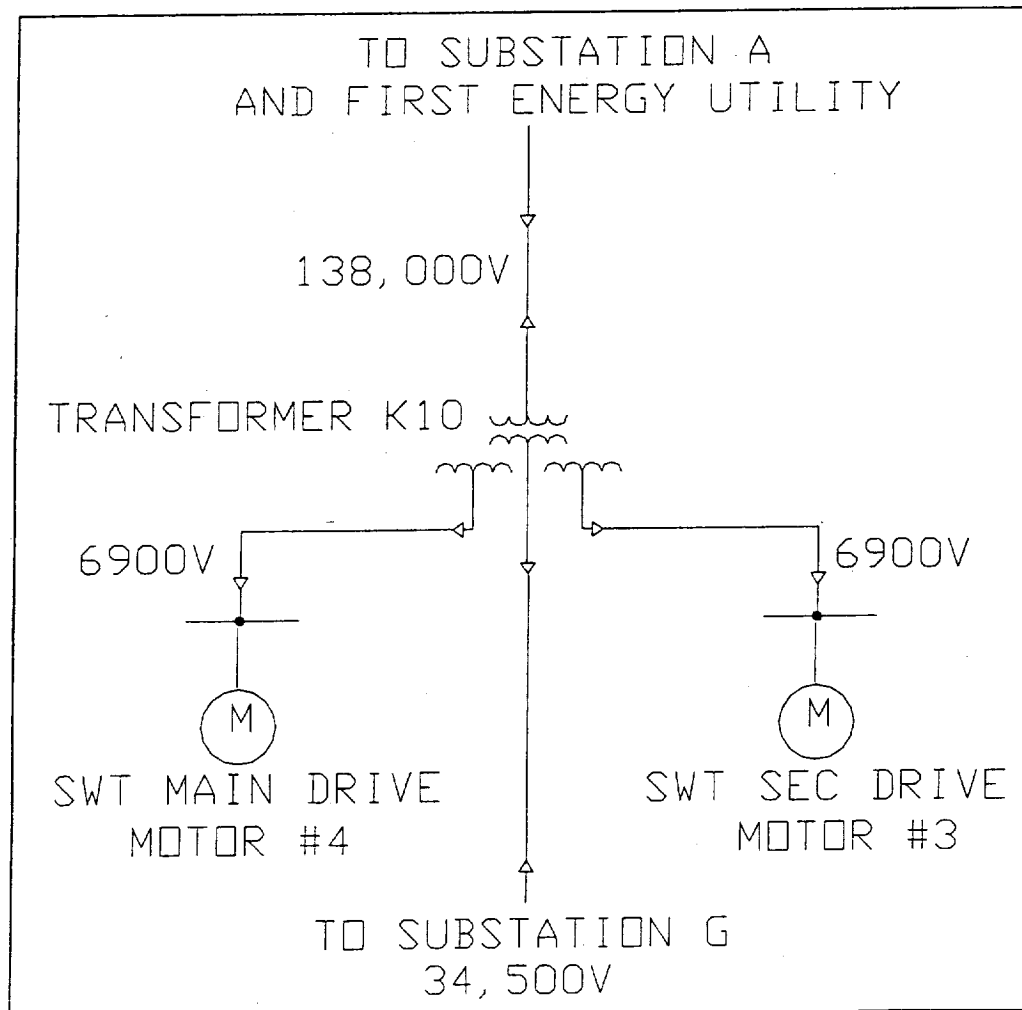
FIGURE 1 – ONE LINE OF XFMR K10

All three incidents were associated with transformer *K10*, one of four transformers feeding the 10 x 10 SWT complex. A simplified one-line of transformer *K10* and its high voltage connections appears in Figure 1.

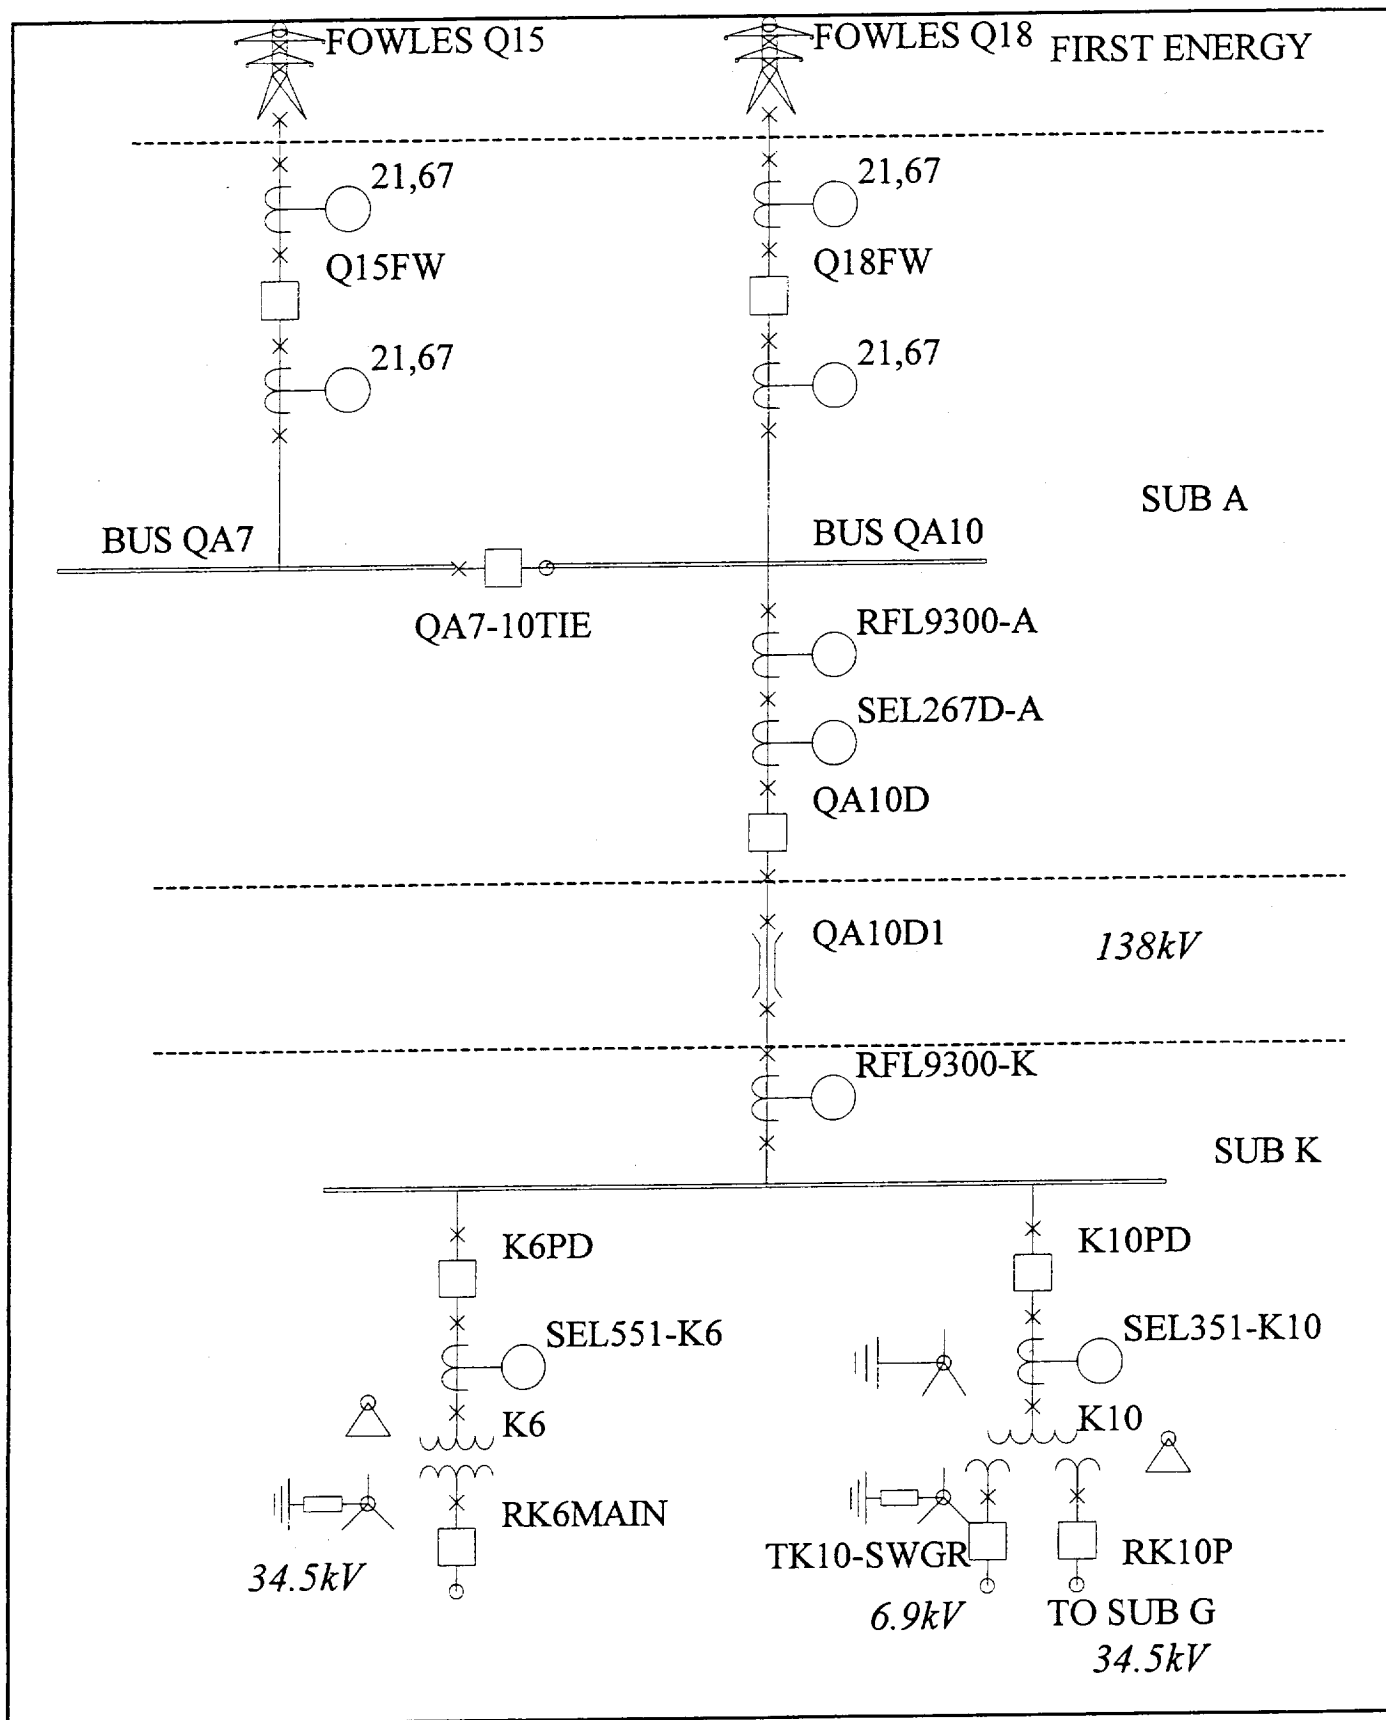
FIGURE 4 – SUBSTATION A – K SIMPLIFIED RELAY 1L DIAGRAM

The following switching was done in the field to isolate the system problem (Refer to Figure 4 for a simplified relay 1L):

- Open CS K10PD, while leaving K6PD closed. The FD at both Substation A and K cleared.
- Open CS K6PD.

- Remove all load from XFMR *K10* and close CS *K10PD*. The ground FD activated again. XFMR *K10* being fed from breaker *Q18FW*.
- Open CS *K10PD* and breaker *Q18FW*.
- Close CS *Q7-10TIE*.
- Close CS *K10PD* energizing *K10* from *Q15FW* via the *QA7-10TIE*. The ground FD did not activate.

This indicated that the system problem was located somewhere on the First Energy utility system. Electric Power Dispatch made several calls to First Energy regarding this. Initially, First Energy thought there was a CT problem on their circuit. However, even after this problem was repaired, NASA continued to get a FD on the *QA10D1* RFL9300. Data was collected from various relays and sent to First Energy. Condensed results appear in the Tables 1 - 6. Raw data appears in Appendix A. All data taken with *K6PD* open, *K10PD* closed, and no load on XFMR *K10*.

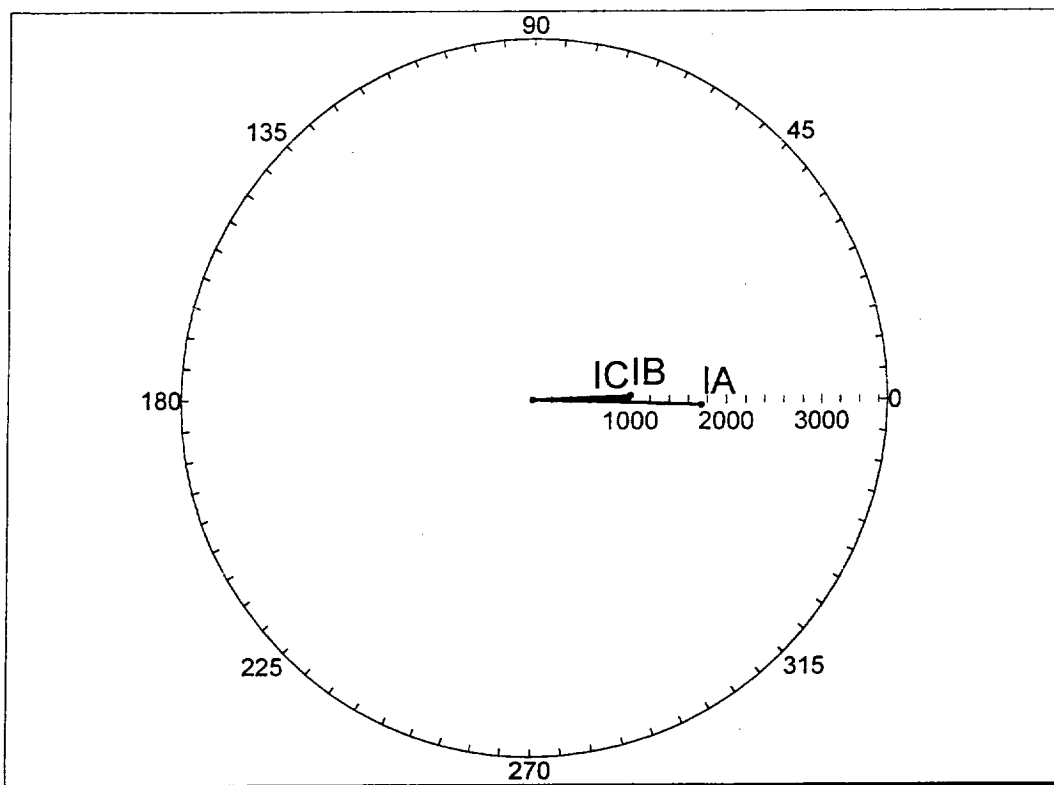
Dashed line at 4-cycles represents snapshot location for Phasor Diagrams plots in Figures 8 & 9.

Figure 8 – XFMR K10 SEL351 Phasor Plot for QA10D1 PH-A Fault
Phase Currents (snapshot at 4 cycles)

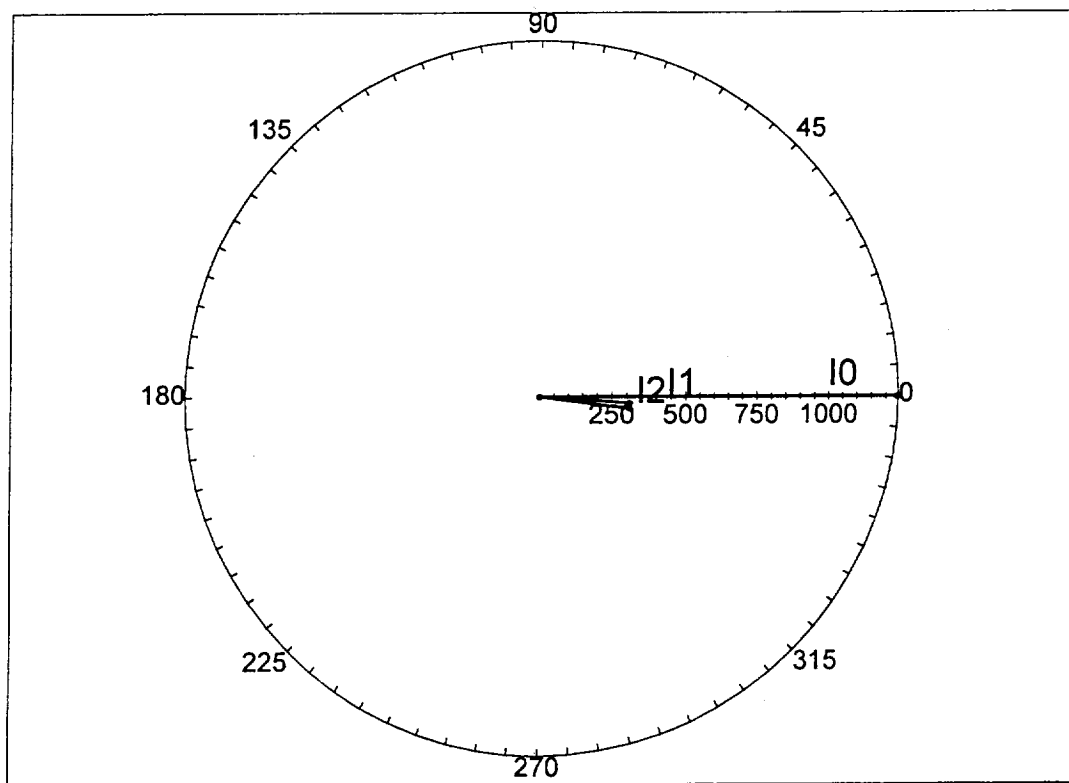
Figure 9 – XFMR K10 SEL351 Phasor Plot for QA10D1 PH-A Fault
Sequence Components (snapshot at 4 cycles)

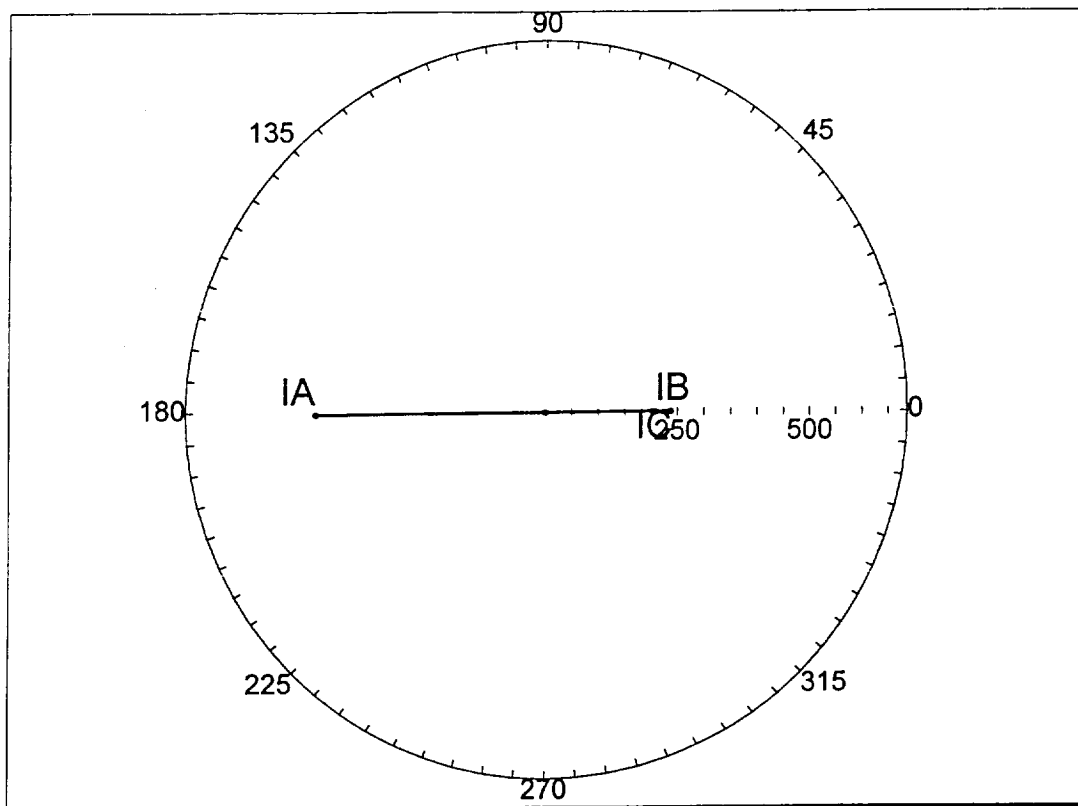
Dashed line at 4-cycles represents snapshot location for Phasor Diagrams plots in Figures 11 & 12.

Figure 11 – XFMR K6 SEL551 Phasor Plot for *QA10D1* PH-A Fault
Phase Currents (snapshot at 4 cycles)

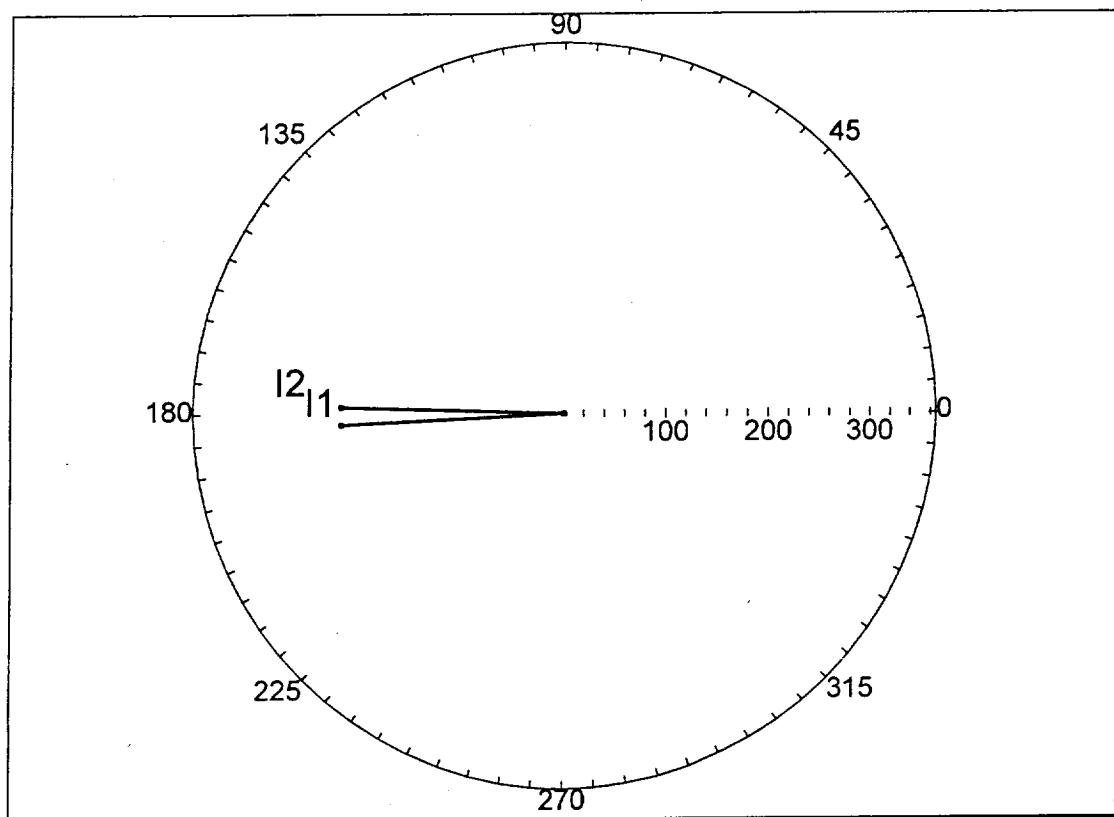
Figure 12 – XFMR K6 SEL551 Phasor Plot for *QA10D1* PH-A Fault
Sequence Components (snapshot at 4 cycles)
